Phase 1 Inspection Report: National Dam Safety Program. Mississippi - Kaskaskia - St. Louis Basin. Lake Adelle Dam, Jefferson County, Missouri

LAKE ADELLE DAM
JEFFERSON COUNTY, MISSOURI
MO 30411

PHASE 1 INSPECTION REPORT NATIONAL DAM SAFETY PROGRAM

Name Of Dam:	Lake Adelle Dam
State Located:	Missouri
Inventory Number:	MO 30411
County Located:	Jefferson County
Stream:	Unnamed Tributary to Skullbones Creek
Date of Inspection:	25 February 1981

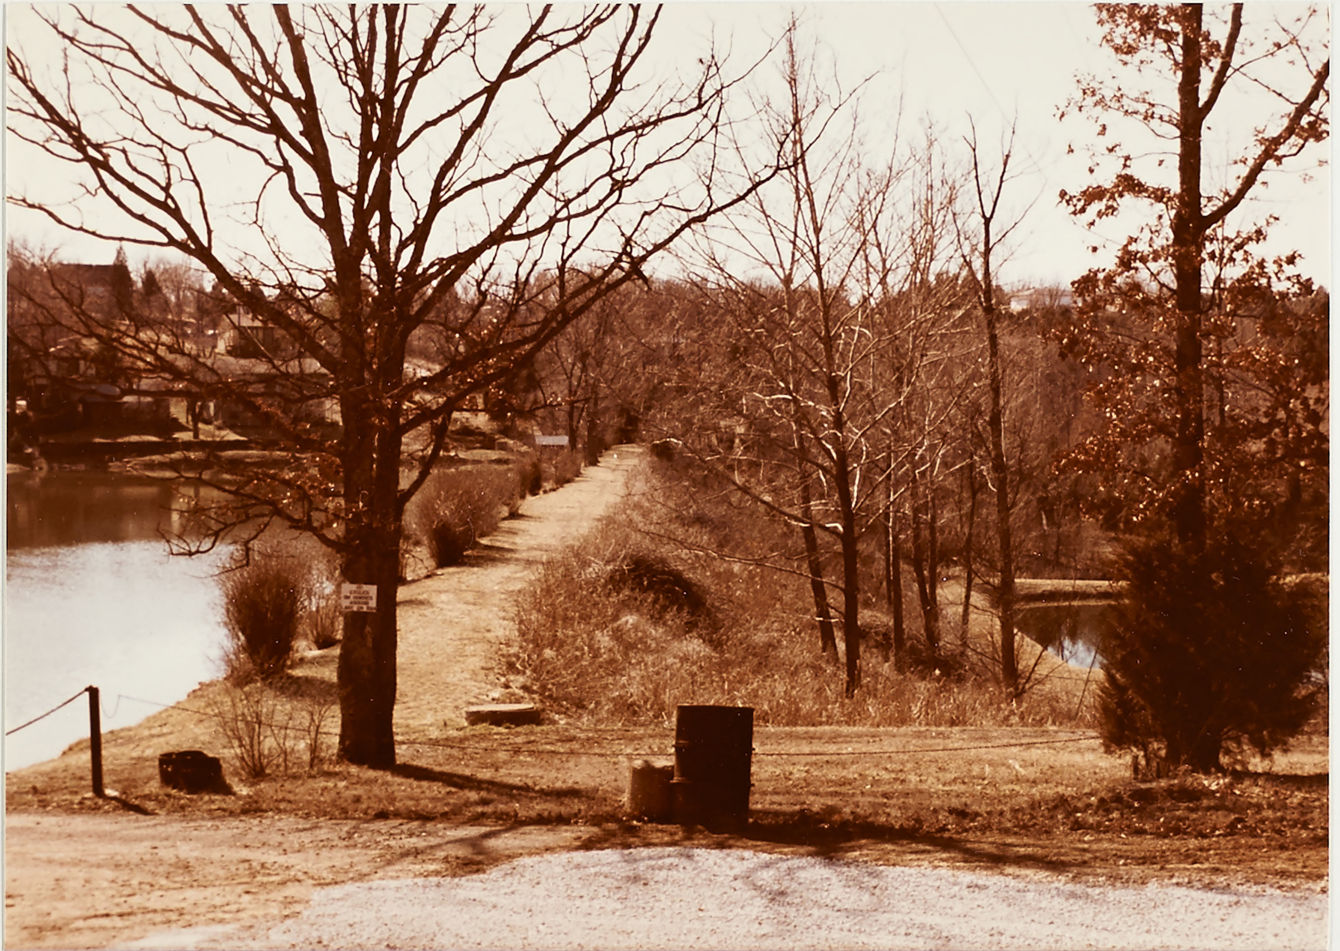
PHOTOGRAPH 1. OVERVIEW OF LAKE ADELLE DAM

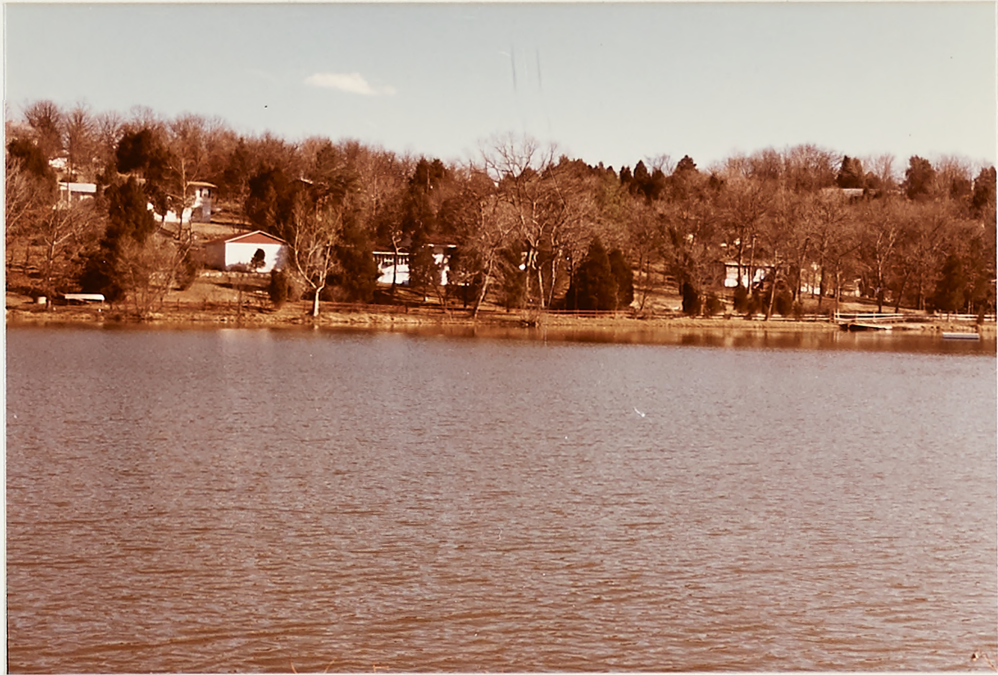
The watershed for Lake Adelle Dam contains approximately 59.4 acres. The surface area of the lake is about 11% of the watershed area when it is at the spillway crest elevation of 621.1 and about 12.5% when it is at the top of dam elevation of 623.5. A view of the lake and residential development surrounding it is given on Photograph 10. The watershed consists of a residential subdivision with average slopes of 14% to 18%.

Photograph 10. View of lake and drainage area from the dam.

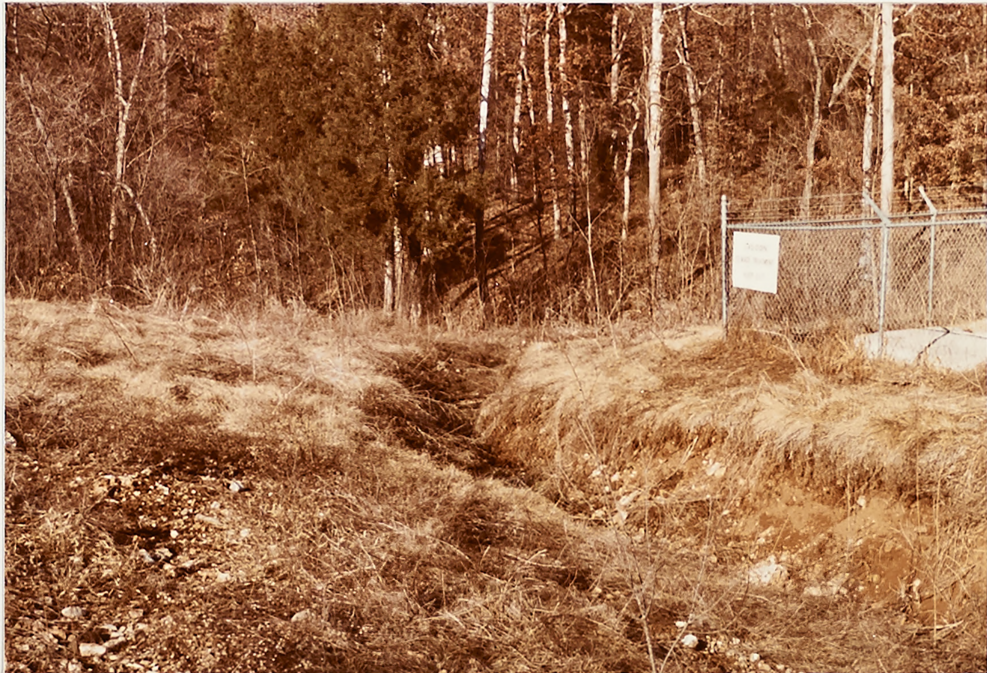
Flow from the wet area near the downstream left abutment and flow in a channel from the hillside immediately west of the dam join just outside the fence on the west side of the sewage lagoons as shown on Plate 4 of Appendix A. From that point to just downstream of the sewage lagoon outlet the channel is trapezoidal with a rock bottom and earth and rock sides. The flow then enters the original stream channel. A view of the discharge channel near the sewage lagoon outlet is given on Photograph 11.

Photograph 11. View of discharge channel.

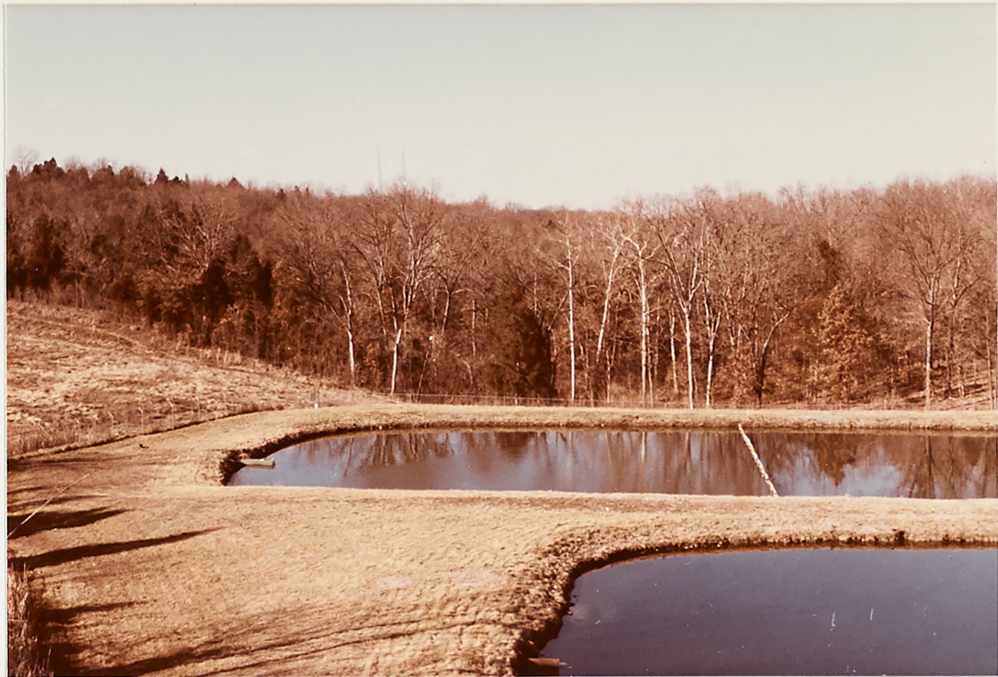
The original downstream channel is a trapezoidal channel and is heavily wooded with underbrush. A view across the sewage lagoons at the downstream channel is given in Photograph 12. The channel has an average slope of about 3% for 0.5 miles downstream of Lake Adelle before it flows into two small lakes. Of the two lakes, the furthest downstream is Cedar Hill Lake (MO 30073). The other lake, located immediately upstream of Cedar Hill Lake, was originally in series with Cedar Hill Lake, but has been modified to include a berm along the right side of the channel to form the present side channel lake and channel dam. Downstream of these lakes the channel continues for another 0.2 miles before its confluence with Skullbones Creek. Photograph 13 shows a view from the bank of the downstream channel of a dwelling located

Photograph 12. View of sewage lagoons and downstream channel beyond them.

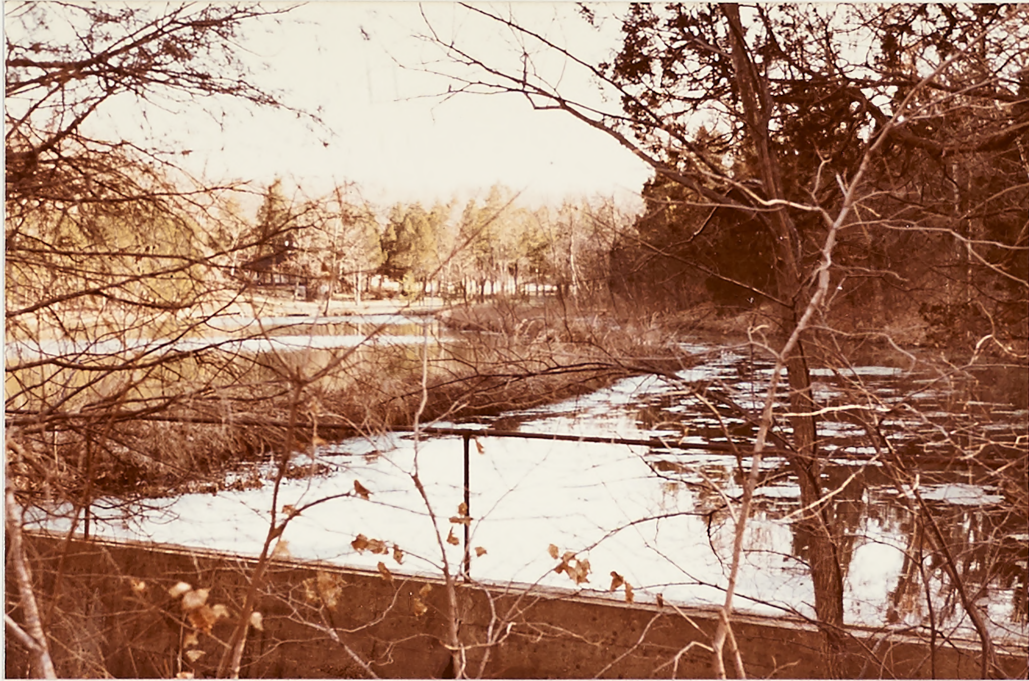
0.4 miles downstream from Lake Adelle Dam. Photograph 14 shows one of the lakes located 0.5 miles downstream from the dam. The downstream channel and downstream lakes can be seen on Exhibit 1 in Appendix B.

Photograph 14. View of downstream lake located approximately 0.5 miles downstream of the dam.
